Examples and  
Thoughts?

ROOFS

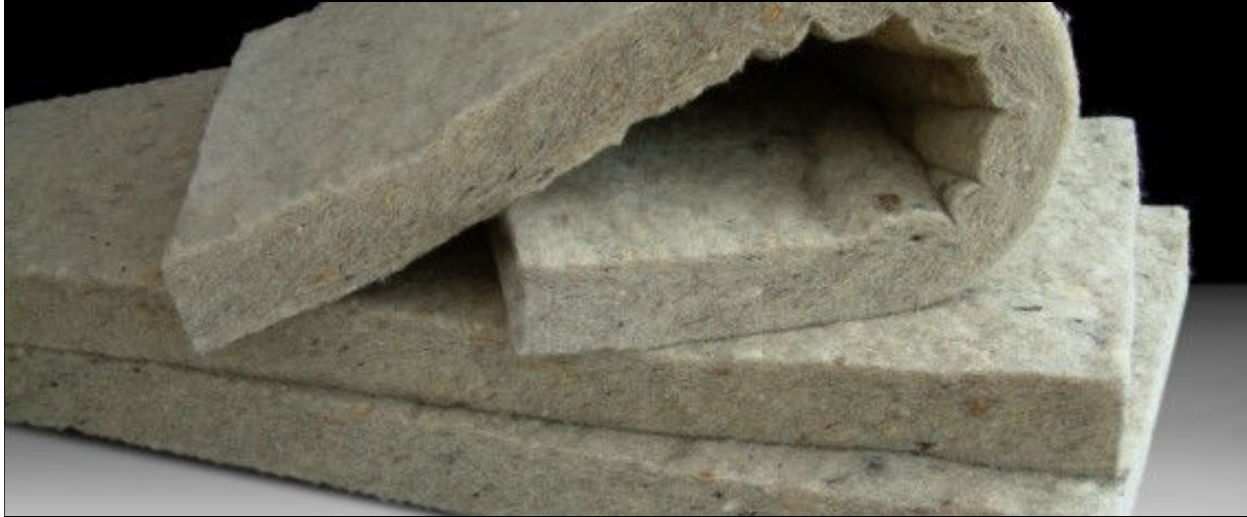
Thermafleece

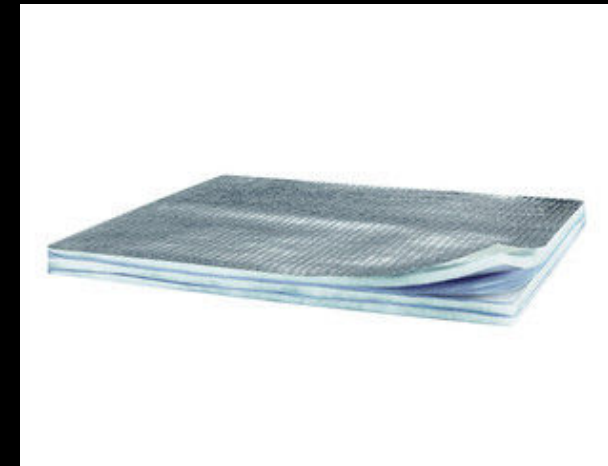
Rigid Board - PIR

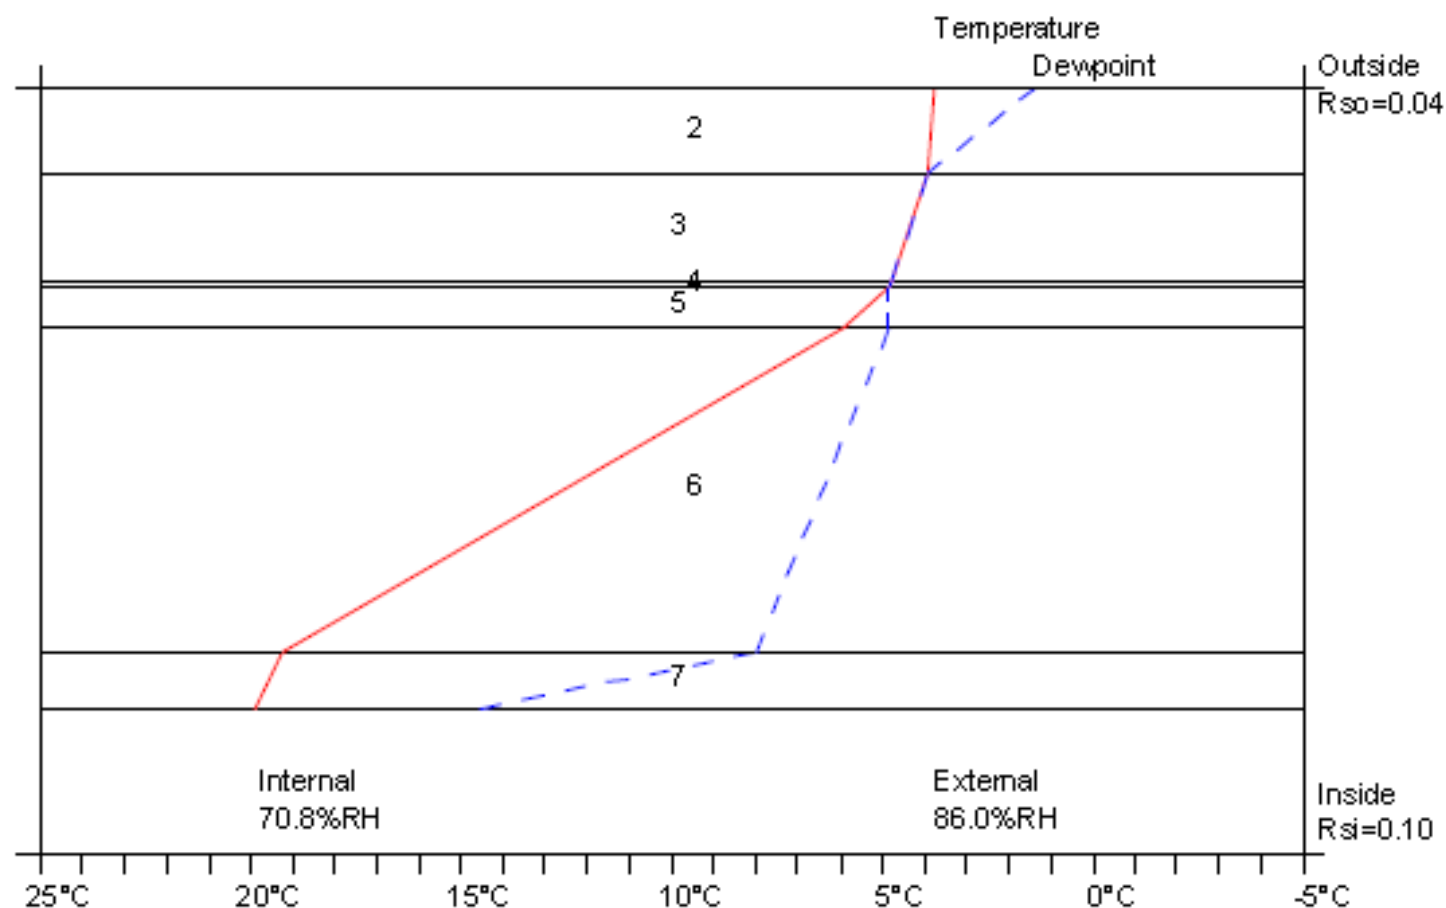
#### Condensation Risk Analysis(no account taken of thermal bridges)

4 - Dwellings with high occupancy, sport halls, kitchens, canteens; buildings heated with unflued gas heaters

Jan (worst)	Feb	Mar	Apr	May	Jun	Jul	Aug	Sep	Oct	Nov	Dec
20.0C 70.8%	20.0C 69.5%	20.0C 67.1%	20.0C 65.8%	20.0C 65.2%	20.0C 67.6%	20.0C 70.3%	20.0C 71.3%	20.0C 70.8%	20.0C 69.9%	20.0C 69.7%	20.0C 70.6%
3.5C 86.0%	3.8C 82.5%	5.7C 80.0%	8.0C 77.0%	11.3C 77.0%	14.4C 76.0%	16.5C 76.5%	16.1C 78.5%	13.8C 81.5%	10.7C 84.0%	6.4C 85.5%	4.5C 86.5%

Interface Temp. °C	Dewpoint Temp. °C	Vapour Pressure (kPa)	Saturated V.P. (kPa)	Worst Cond. (g/m <sup>2</sup> )	Peak Buildup (g/m <sup>2</sup> )	Conden- sation
1 Outside surface resistance	3.8	1.4	0.67	0.80			No
2 Clay tiles (BS5250)	3.9	3.9	0.81	0.81	896.8 in Jan	4951 in Apr	Yes
3 Airspace 25mm between slates/tiles underlayer	4.8	4.8	0.86	0.86			No
4 Tyvek Supro	4.8	4.8	0.86	0.86	942.3 in Jan	3674 in Mar	Yes
5 Cavity >=25mm, roof (CIBS)	5.9	4.8	0.86	0.93			No
6 Thermafleece	19.3	8.0	1.07	2.23			No
7 Lath Plaster	19.9	14.6	1.65	2.32			No
8 Inside surface resistance							No

Worst case internal / external conditions for graph : 20.0°C @ 70.8%RH / 3.5°C @ 86.0%RH

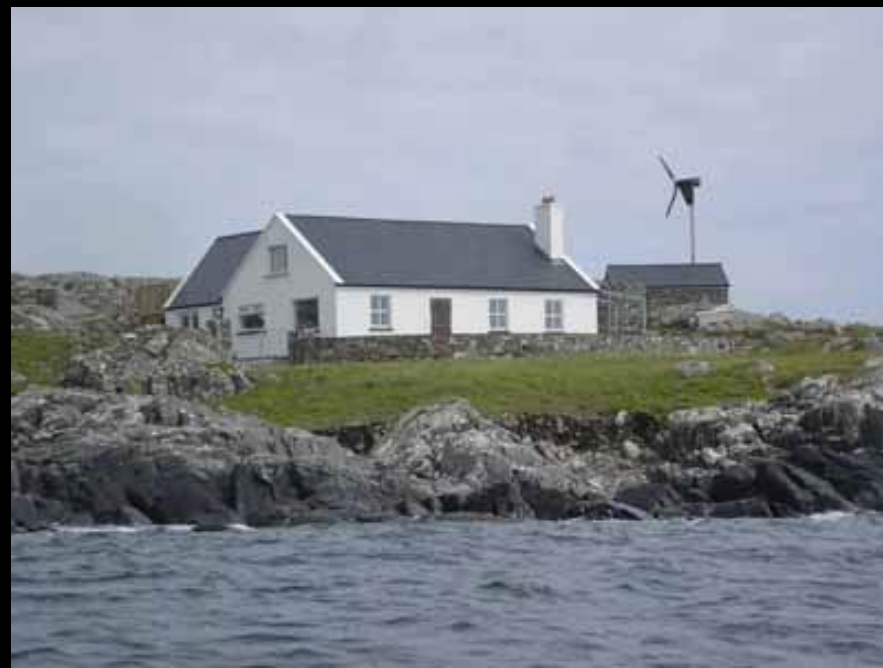
A house with a pole-mounted turbine  
© Proven Energy Ltd
